# Manhole Inspection Summary

Manhole # S29GG1024MH

Insp Date: **4/13/07 11:51 AM**

**Location** Address: **700 40TH ST**

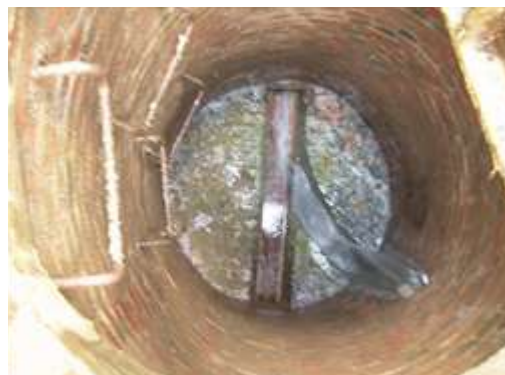
Top View

Bench debris.

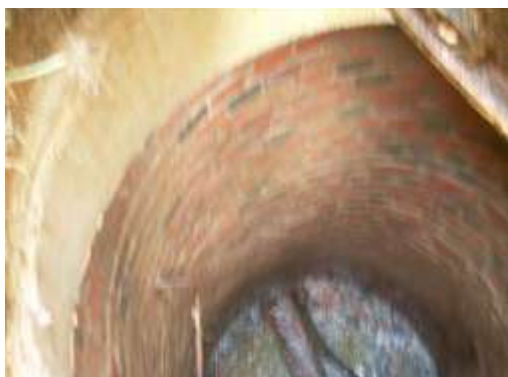
Defect

Corbel and Barrel infiltration.

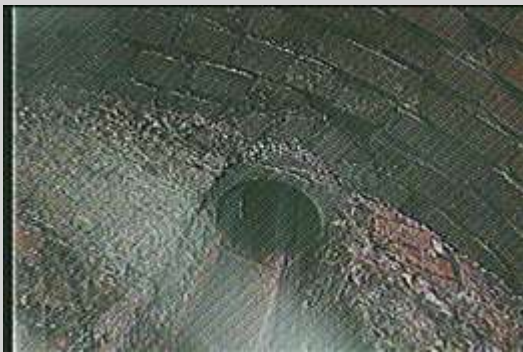
### 8 in. Circular Gravity Sewer Pipe Out @ 12 O'Clock

Infiltration: **None** Pipe Seal Cond: **Cracked**

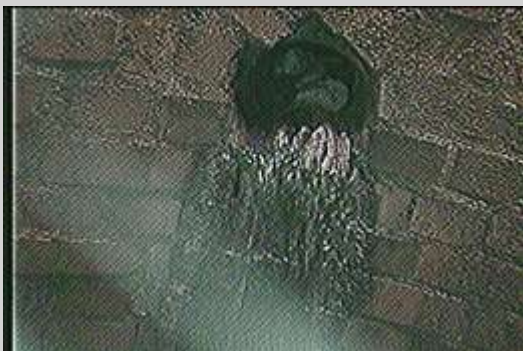
### 6 in. Circular Gravity Sewer Pipe In @ 4 O'Clock

Deposits: ☐ None ☐ Mud ☐ Sludge ☒ **Debris** ☐ Grease

Silt Depth: **1** (in.) Deposits Extent: **Light**

Infiltration: **None** Pipe Seal Cond: **Roots**

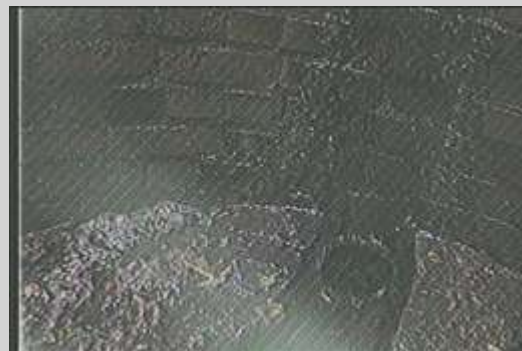
### Drop In @ 4 O'Clock

Barrel deterioration and infiltration.

Drop Condition: **Clogged**

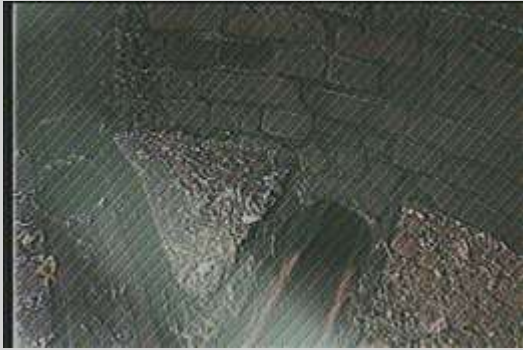
Pipe In @ 6 O'Clock

Barrel deterioration and infiltration.

Pipe Seal Cond: **Cracked**
